OUT OF THE BOX INTO A PIPE:

Use of Large Diameter HDPE Pipe in Place of Channels

Preya P. Balgobin, P. Eng. (R.V. Anderson Associates Limited), Gerry Sigal, P. Eng. (Consultant), Marek Krynski, P. Eng. (Regional Municipality of Durham)

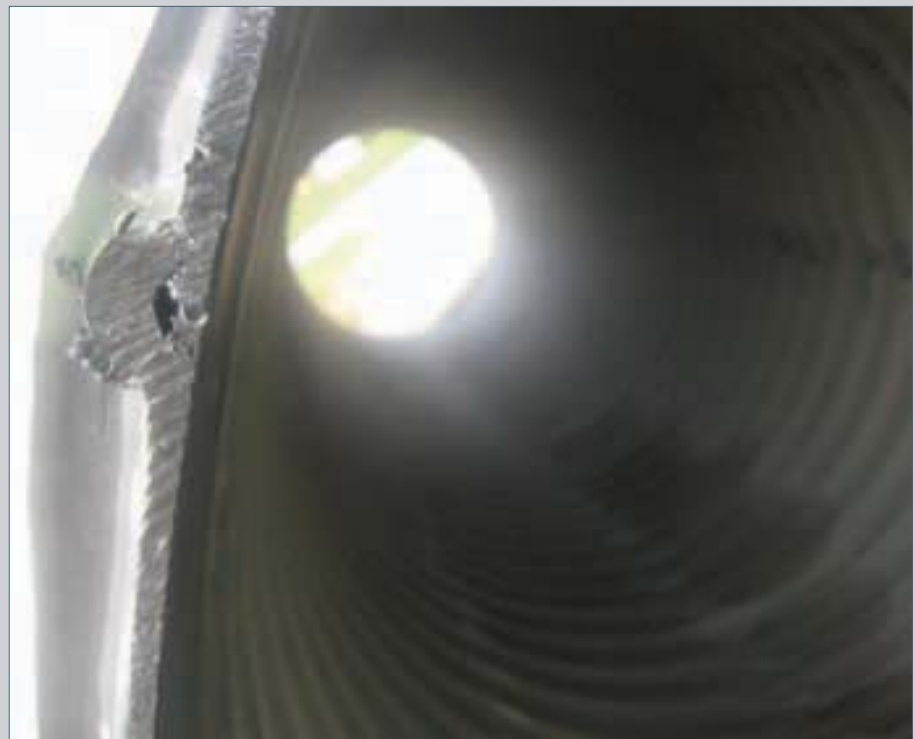
Figure 1: 5mm diameter channel on exterior of HDPE pipe

water pouring out of a small hole in the corrugated portion of the HDPE pipe. A closer inspection revealed a small channel, approximately 5mm in diameter, that runs along the length of the exterior of the smooth inner pipe and connects all the ribs of the pipe (see Figure 1).

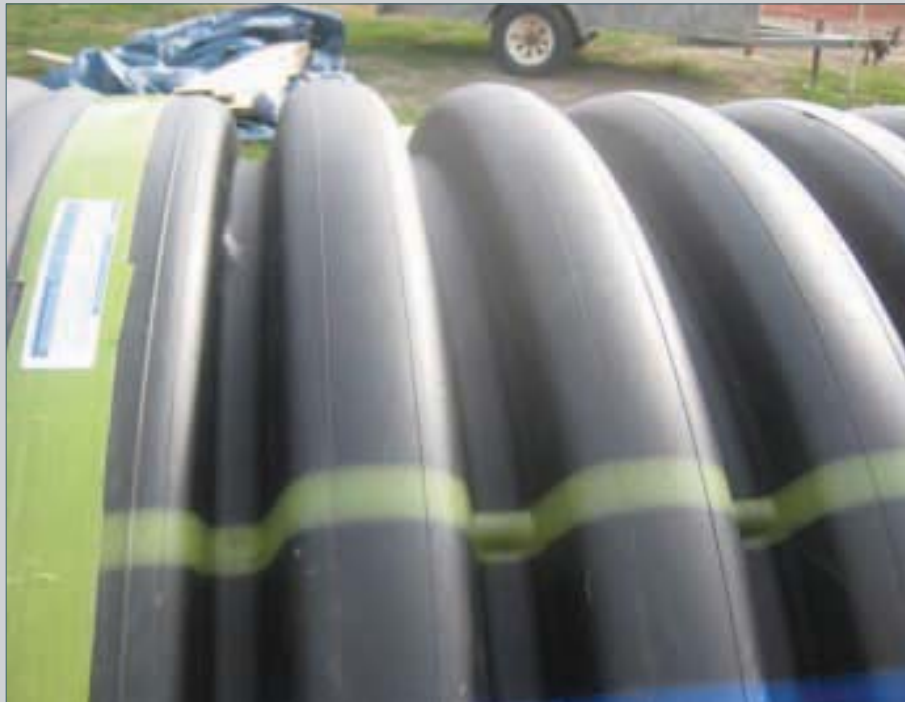
Figure 2: 5mm diameter channel termination at end of pre-fabricated pipe segment.

The HDPE pipe is supplied in pre-fabricated segments of equal lengths (bends and manways are supplied separately) and, in each pre-fabricated segment, a 5mm diameter channel runs through the ribs and is terminated and sealed at the last rib, thereby preventing fluid from entering the ribs (see Figure 2). However, in order to fit the pipe segments to the required length, the pre-fabricated segments at the inlet and outlet of the by-pass needed to be cut in the field. Cutting the pipe segments also cut through the small channel, which allowed water to flow from the influent and effluent chambers into the first and last ribs respectively.

in winter, the resulting expansion might cause the pipe to crack. To remedy the problem, the 5mm diameter channel was sealed using construction foam and then covered with Blueskin® (a high-performance, self-adhering, waterproofing underlayment) to prevent water from entering. Once this was done, the leak between the pipe and the concrete chamber was fixed and the leak test repeated. The system passed the leak test and another important consideration about installing the HDPE pipe was discovered.

At a later date, the manufacturer was asked about the purpose of the small channel and they indicated that the channel is needed in the manufacturing of corrugated HDPE pipe to vent hot air from the corrugations.
