OUT OF THE BOX INTO A PIPE: Use of Large Diameter HDPE Pipe in Place of Channels

Preya P. Balgobin, P. Eng. (R.V. Anderson Associates Limited),
Gerry Sigal, P. Eng. (Consultant),
Marek Krynski, P. Eng. (Regional Municipality of Durham)

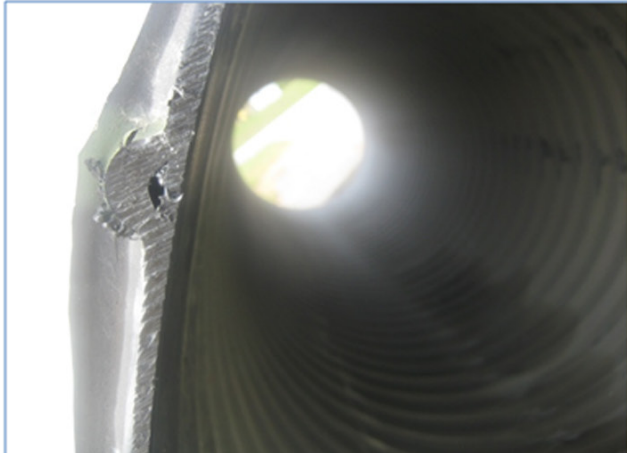
The second unexpected event occurred during leak testing. When the leak test was first performed, a small leak was observed at the connection point between the HDPE pipe and the newly constructed concrete effluent chamber at the HDPE pipe's outlet end. The system was emptied, but when workers entered the concrete chamber repair the leak, they observed water pouring out of a small hole in the corrugated portion of the HDPE pipe. A closer inspection revealed a small channel (approximately 5 mm in diameter) that ran along the length of the exterior of the smooth inner pipe, and connected all of the ribs of the pipe (see Figure 1).

Figure 1: 5 mm diameter channel on exterior of HDPE pipe

Having water in the ribs of the HDPE pipe was not desirable as it posed the risk that, if the water were to freeze in winter, the resulting expansion might cause the pipe to crack. To remedy the problem, the channel was sealed using construction foam, and then covered with Blueskin® (a high-performance, self-adhering, waterproofing underlayment) to prevent water from entering.

At a later date, the manufacturer was asked about purpose of the small channel, and they indicated that the channel is needed in the manufacturing of corrugated HDPE pipe to vent hot air from the corrugations.

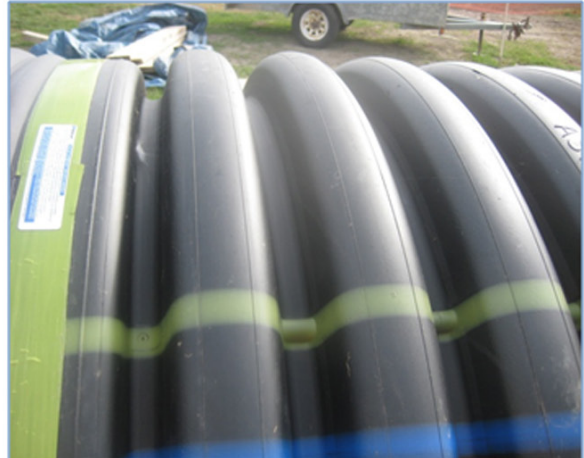
Figure 2: 5 mm diameter channel termination at end of pre-fabricated pipe segment.

The HDPE pipe is supplied in pre-fabricated segments of equal lengths (with bends and manways supplied separately). In each pre-fabricated segment, a 5 mm diameter channel runs through the ribs and is terminated and sealed at the last rib to prevent fluid from entering the ribs (see Figure 2). However, for the bypass installation, the pre-fabricated segments at the inlet and outlet of the bypass needed to be cut in the field to fit the pipe segments to the required length. Cutting the pipe segments also cut through the small channel, which allowed water to flow from the influent and effluent chambers into the first and last ribs respectively.
