Installation of 1,650 mm
concrete pressure pipe.

COURTICE COMPLETES CONSTRUCTION ON OUTFALL SEWER

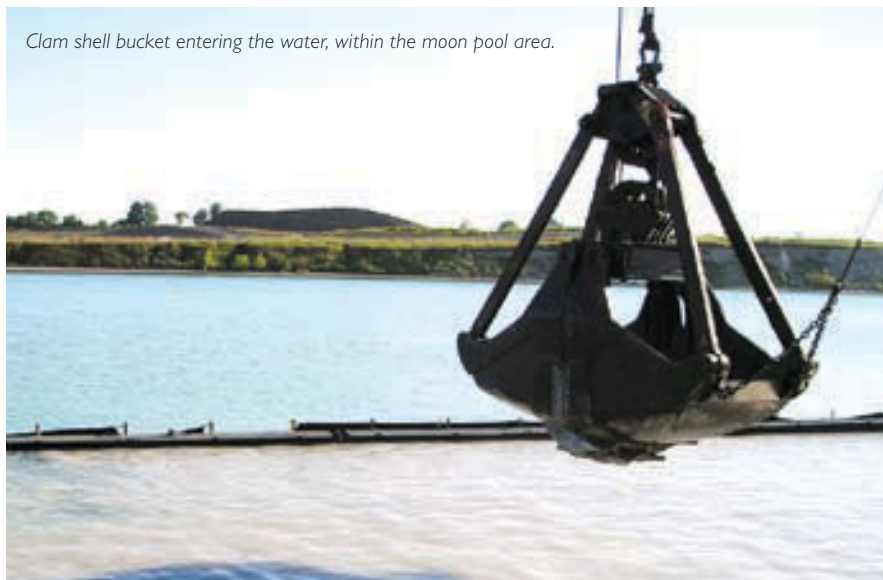
Clam shell bucket entering the water, within the moon pool area.

Conventional, open-cut marine trenching was used for the installation of the pipeline offshore in Lake Ontario. The marine trench was excavated using a crane and clam shell bucket, mounted on a barge, equipped with a heavy duty bucket. Excavation equipment was mounted on a floating barge equipped with spuds to hold it in position while

during construction, which could adversely affect fish and plant growth in the lake. To ensure siltation was minimized, a silt fence (moon pool curtains) was placed around the clam bucket removing the material, and turbidity was monitored throughout dredging to ensure silt transport was minimal. The silt levels in the lake were tested before construction began to have a background level of comparison. This level was then used to set a maximum limit of silt during the construction period. If this allowable level was exceeded, work was to be halted until the level of silt decreased. The allowable level was never exceeded during the construction phase of this project. As added protection to aquatic life, it was determined that work in the water could only be completed from July 1 to March 31, which is outside of the fish spawning season.
